UNDERWATER BRIDGE INSPECTION REPORT

STRUCTURE NO. 55520
CSAH NO. 12
OVER THE
ZUMBRO RIVER
DISTRICT 6 - OLMSTEAD COUNTY

PREPARED FOR THE
MINNESOTA DEPARTMENT OF TRANSPORTATION
BY
COLLINS ENGINEERS, INC.
JOB NO. 5221 (CEI 151)

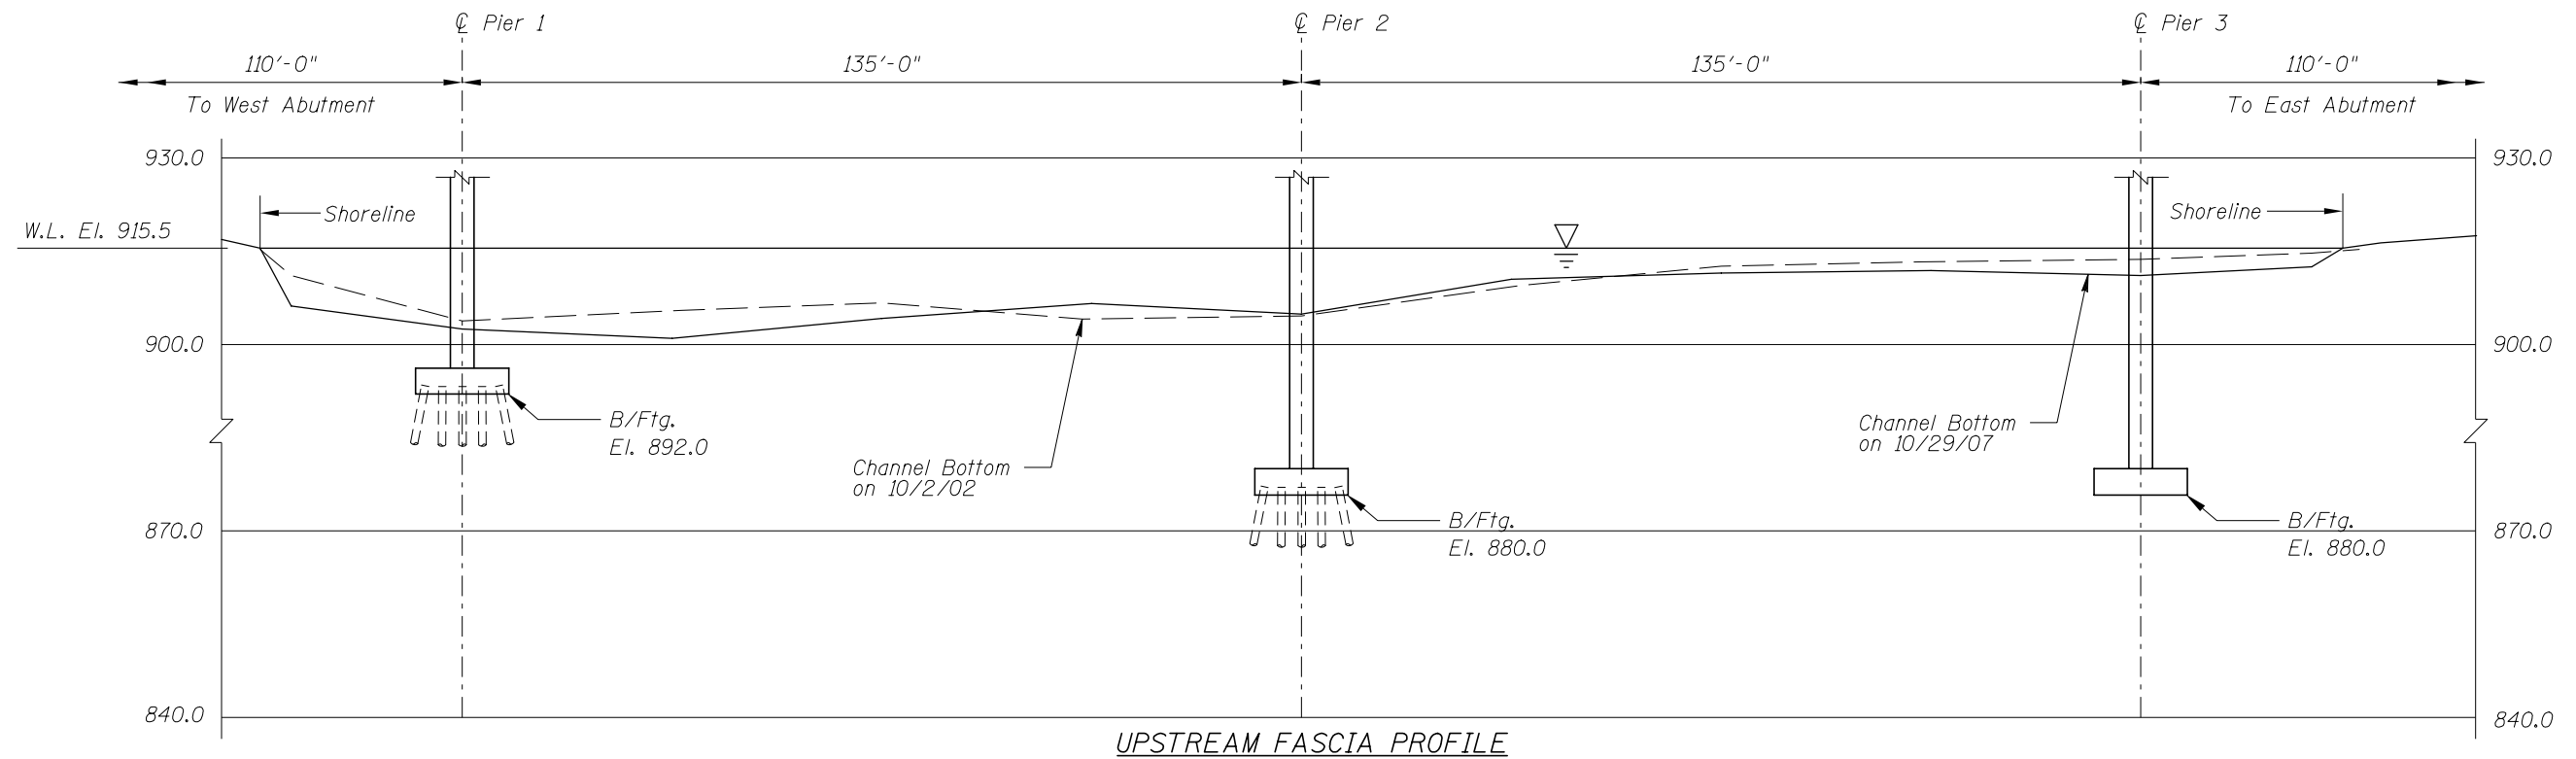
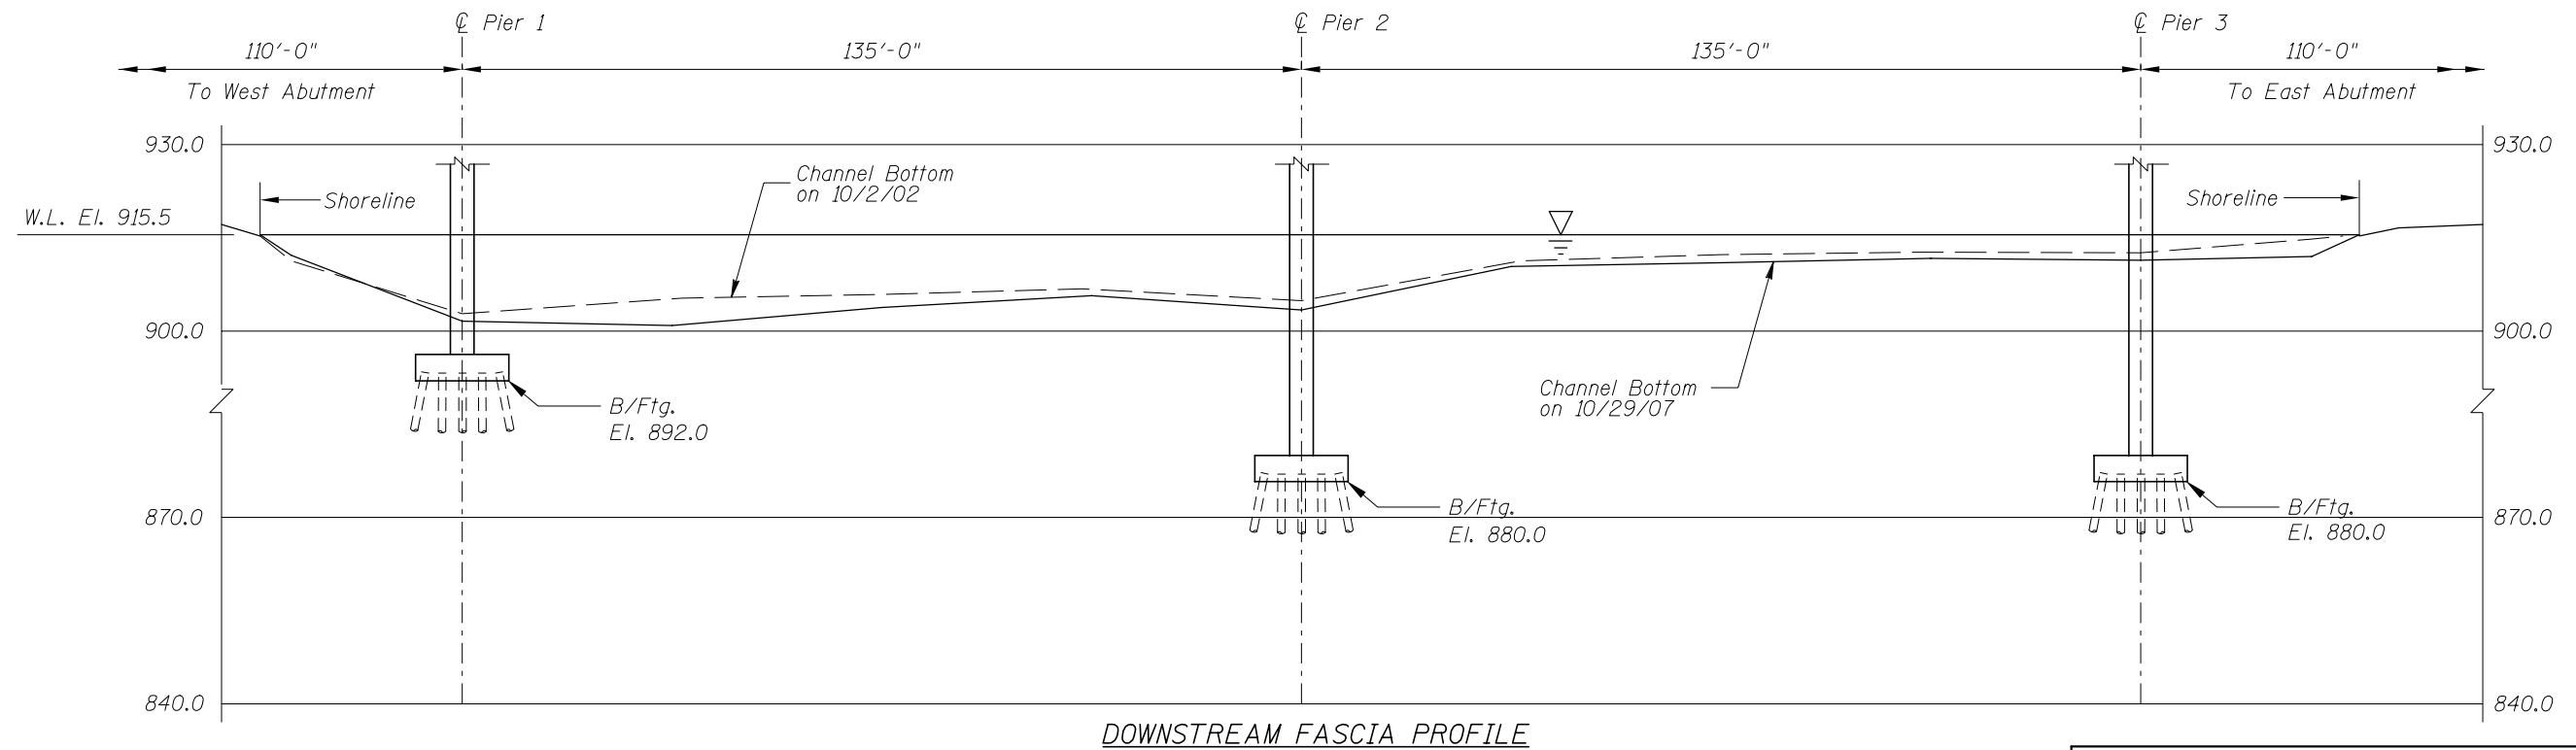
Drawn By: LJ	COLLINS ENGINEERS	123 North Wacker Drive Suite 300 Chicago, IL 60606 (312) 704-9300 www.collinsengr.com	Date: OCT, 2007
Checked By: DGS			Scale: NTS
Code: 52210151			Figure No.: 1

- Footing exposure at Pier 1 was observed all around the pier with a maximum vertical exposure of 1 foot along the downstream end and east side of the pier. The surface of the footing was rough with 1 inch irregularities. At the location where the shaft meets the column, voided areas with penetrations of 1 to 2 inches and 2 to 3 inches high were observed. There was a 3 to 4 feet area where the footing was not exposed due to infilling at the west face.

- A tree trunk 1 foot diameter was observed along the shore side of Pier 1 on top of the footing extending from the upstream nose to shaft midpoint.
- The upstream nose of Pier 2 stops at 7 feet below water and cuts back 1.5 feet. Debris has accumulated in this area from channel bottom up 4 feet, consisting of logs and branches 1.5 feet diameter and smaller. A tree trunk was observed from channel bottom to 2 feet above water along the east face of pier.

- A scour depression 3 feet radius and 1 foot deep was observed at the upstream end of Pier 3.
